**THE IDENTIFICATION AND QUANTIFICATION OF FULL-
DEPTH PATCHING NEED USING REMOTE SENSING
TECHNOLOGY**

In Partial Fulfillment
of the Requirements for the Degree
Master of Science in the
School of Civil and Environmental Engineering

Georgia Institute of Technology
AUGUST 2017

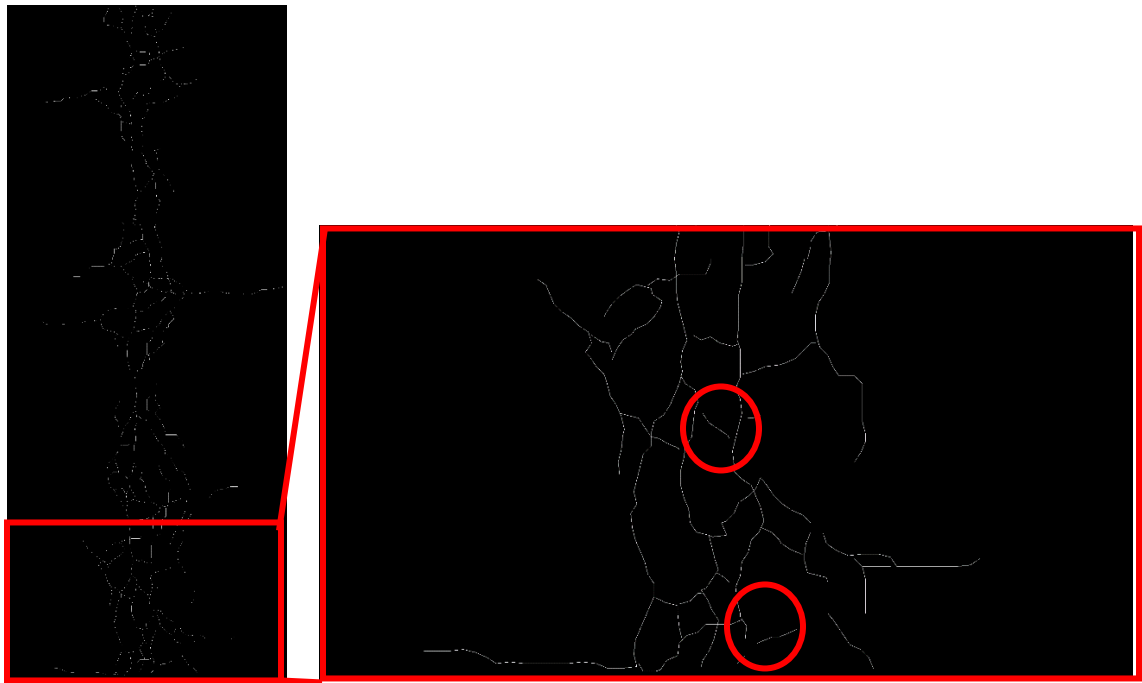
Figure 2-5 Crack map processing: (a) semi-automatic detection results, (b) image closing, and (c) skeletonization and dilation results

In Figure 2-5, the results of the semi-automatic crack detection process are shown. The circled locations indicate areas in the crack map where the cracks are likely joined; however, due to the crack detection process, the cracks in the resultant image do not join as they should. This is problematic for identification of patching area because the pavement polygons are not closed, and therefore cannot be recognized as polygons by MATLAB. To join crack branches to nearby crack segments and end points, the images are first processed using image closing as shown in Figure 2-5b. Closing the image draws together closely located endpoints and branch points to help make connections.

The images are then skeletonized to reveal the basic crack structure before being dilated to thicken the crack lines. The final result of this process is shown in Figure 2-5c. Through processing, the joining of cracks fully segments the image into pavement cracks and polygons/background. From this binary data, the polygons/background data can be

The semi-automatic crack detection method approximates crack position using manual input. Because of this, the produced crack maps are not as accurate and smooth as automatic crack detection results. This process often results in disconnected cracks that cannot be used for the full-depth patching identification process. To correct for these inherent errors, the images are processed using MATLAB to join cracks and close polygon loops. The steps for image processing are illustrated in Figure 2-5 below.

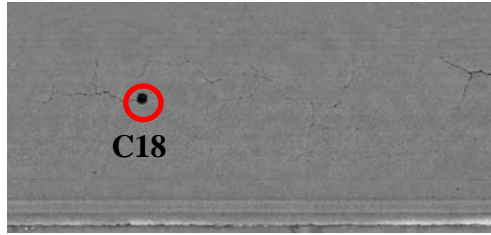
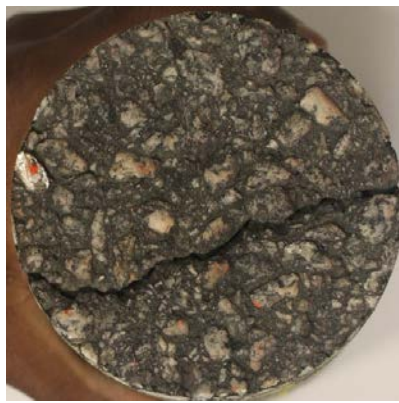
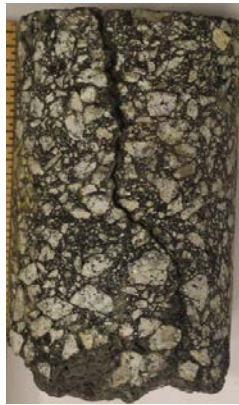
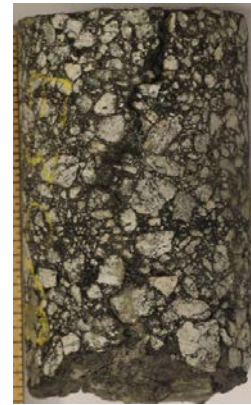
Figure 3-7 Pavement core C18

Although the crack penetrates through the full length of the core, the crack behaves differently on the two sides. On one side, pictured in Figure 3-7a, the crack width is constant through the top layers and begins to change direction and narrow in width in the bottom layer. Contrarily, on the other side, the crack is wide at the top of the core and visibly changes width as it propagates through the top pavement layers. The behavior of crack width through the layers may indicate an issue inherent to the materials and bonding of the layers. This may indicate why the crack depth is significantly higher than expected given the surrounding crack density.

In addition to C4, C18 has an unusually high crack depth for the surrounding crack density. This core, shown in Figure 3-7 below, has a low crack width and minimal spalling, but the crack extends to the full depth of the core.

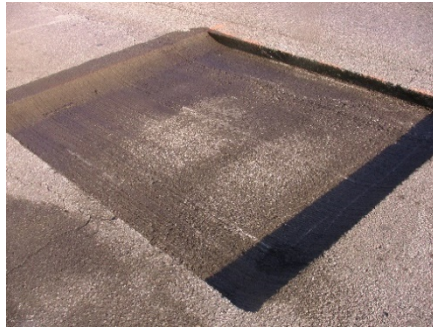
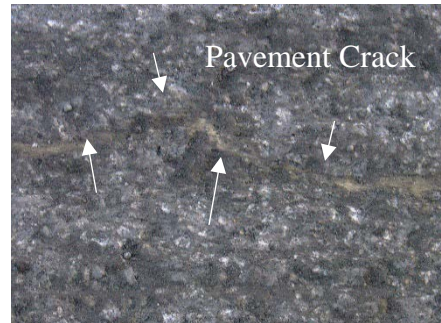
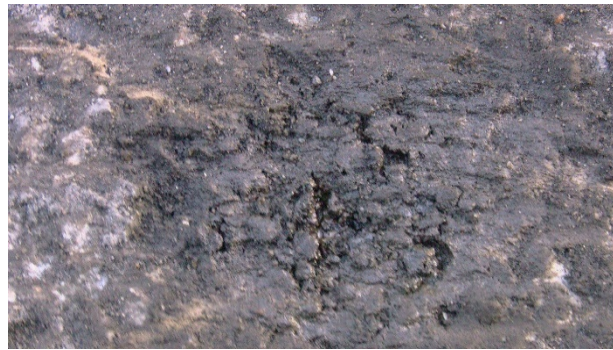
Figure 3-8 Cracking and crumbling on 4" milled surface

For this project, GDOT was performing full-depth patching procedures for both directions of the roadway before performing a 1-in. resurfacing. The 4-in. milled surface for full-depth patching is shown in Figure 3-8a and the other two figures show close-up views of the surface. In several cases for the patching, upon further inspection, cracks were still visible in the 4-in. milled surface (Figure 3-8b). In some cases, the surface even showed severely broken/crumbling material (Figure 3-8c). These defects can weaken the structural integrity of the roadway and are likely to lead to similar problems in the future.

When performing full-depth patching, removing material to the correct depth is equally as essential as identifying the correct locations for patching. Once the defective material is removed, the milled surface serves as the base for the asphalt material used as filler. If this base is unstable or defective in any way, the foundation is no longer solid and the new surface will deteriorate much more quickly. The images in Figure 3-8 were

taken from US Highway 80 near Savannah, Georgia after the top four inches of pavement were milled as part of a full-depth patching procedure.

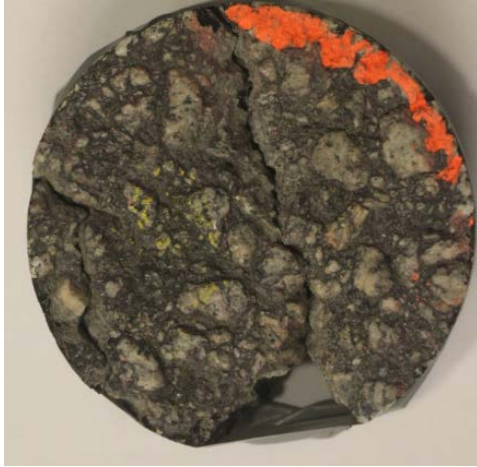
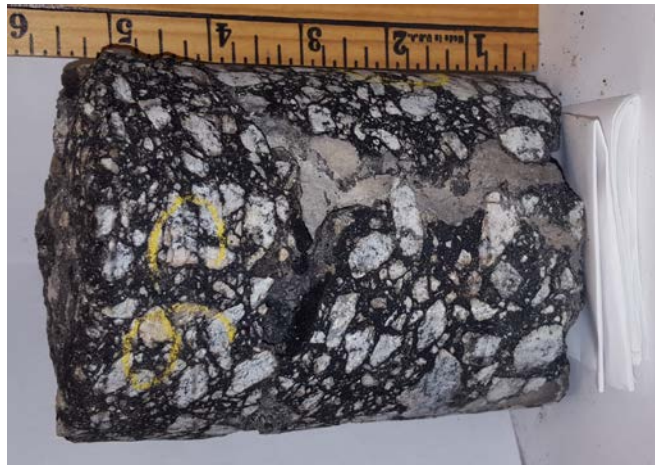
Figure B-3 Core C6 a) top and b) side showing bottom-up cracking

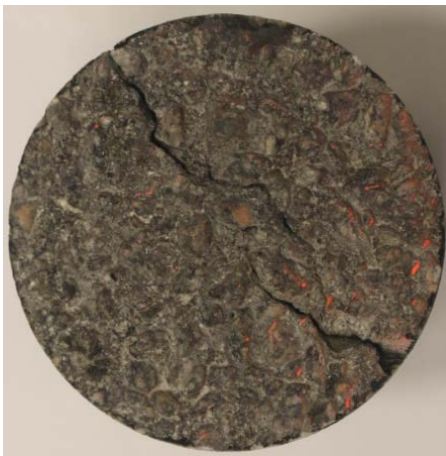
Figure B-4 Core C7 a) top and b) side

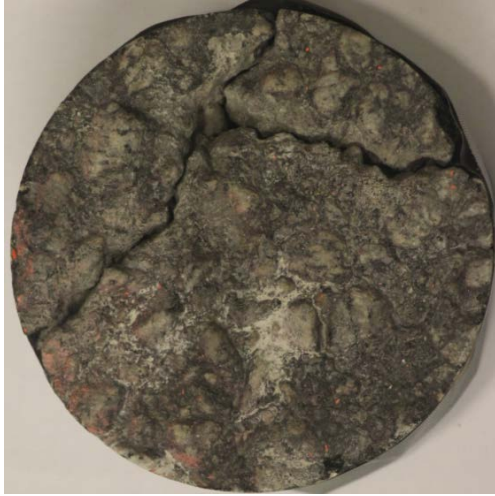
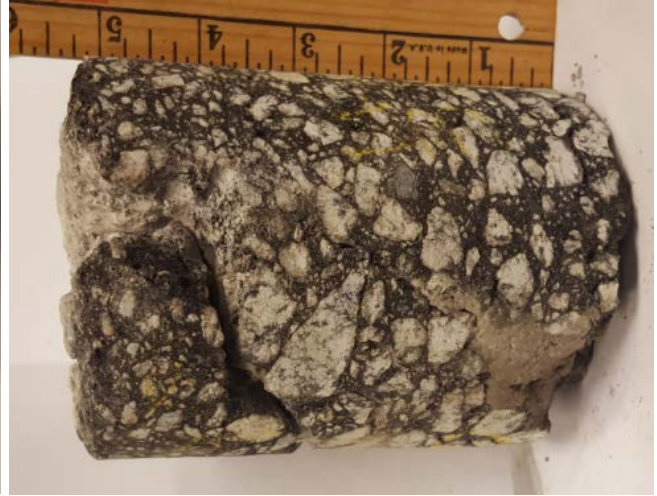
Figure B-5 Core C8 a) top and b) side showing bottom-up cracking

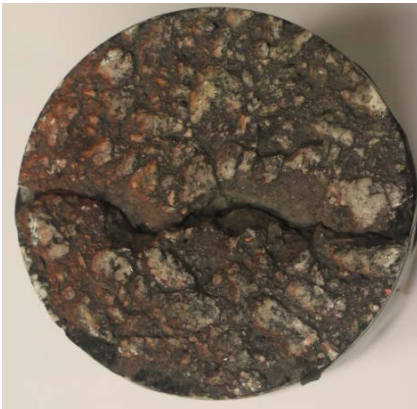
Figure B-6 Core C9 a) top and b) side

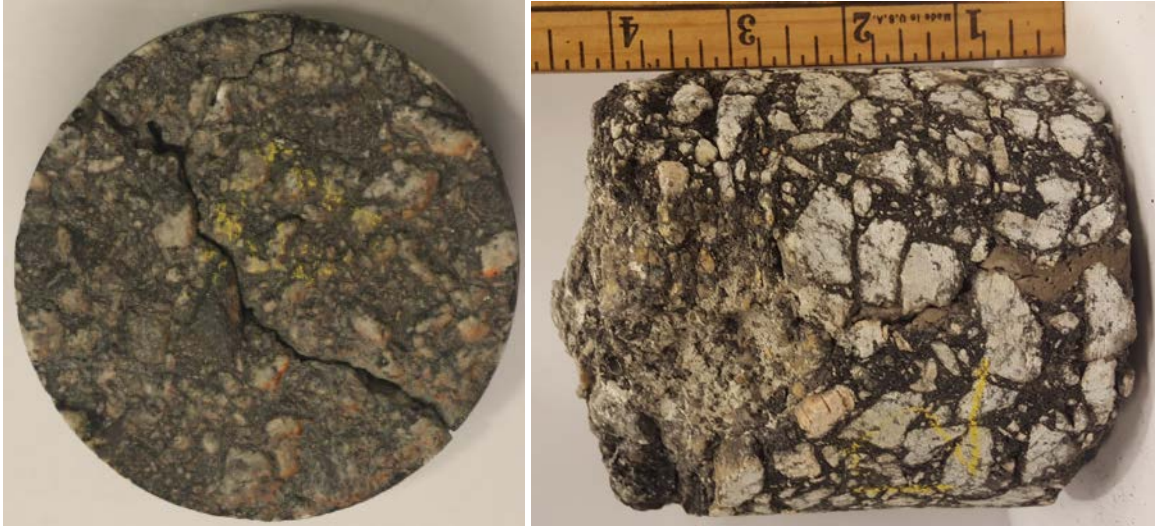
Figure B-9 Core C12 a) top and b) side showing bottom-up cracking

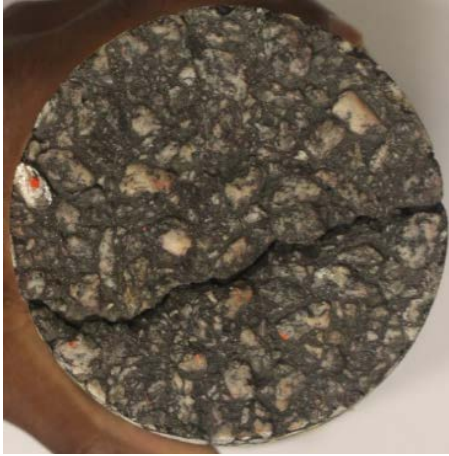
Figure B-11 Core C18 a) top and b) side

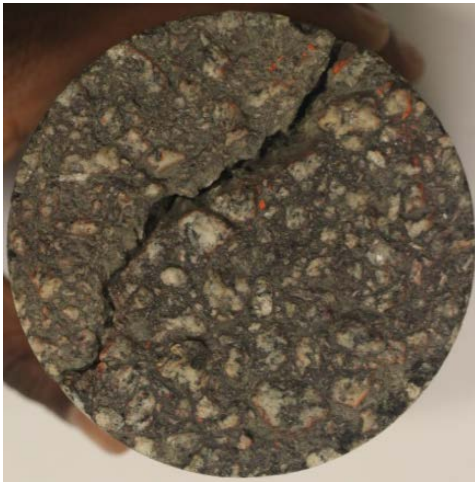
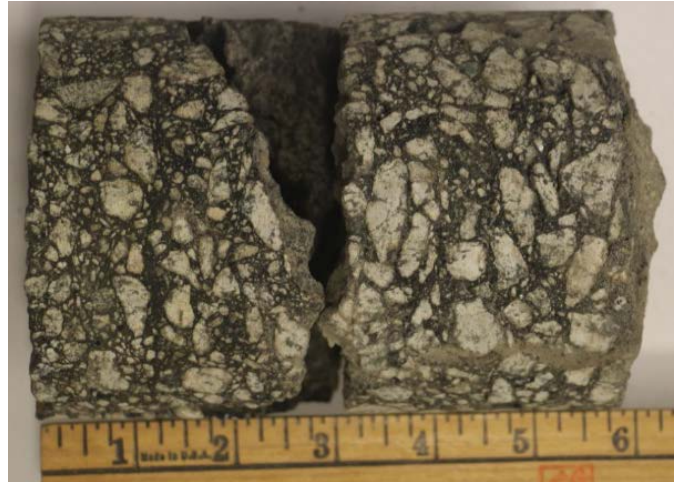
Figure B-12 Core C19 a) top and b) side

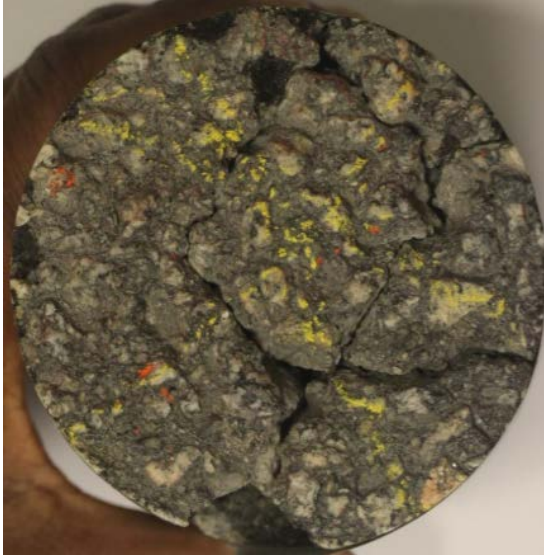
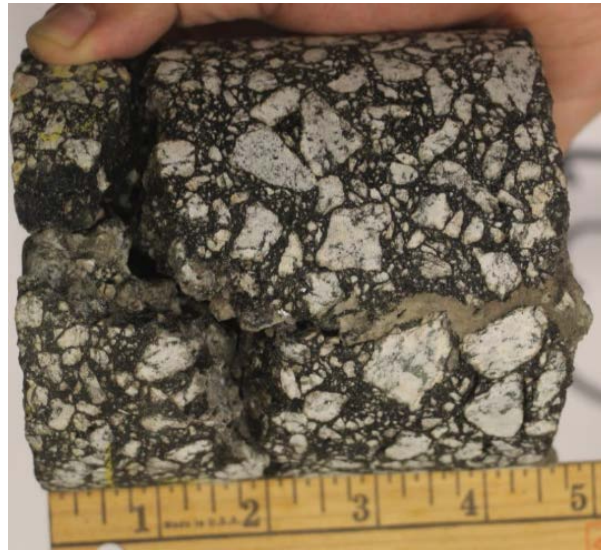
Figure B-13 Core C21 a) top and b) side showing bottom-up cracking
